# Abbey Pynford

## Case Study—Highbury Quadrant

#### Abbey Pynford Selected for the Decent Homes Project

**Scope of Works:** New piled raft underpinning slabs to two 5 storey blocks of flats

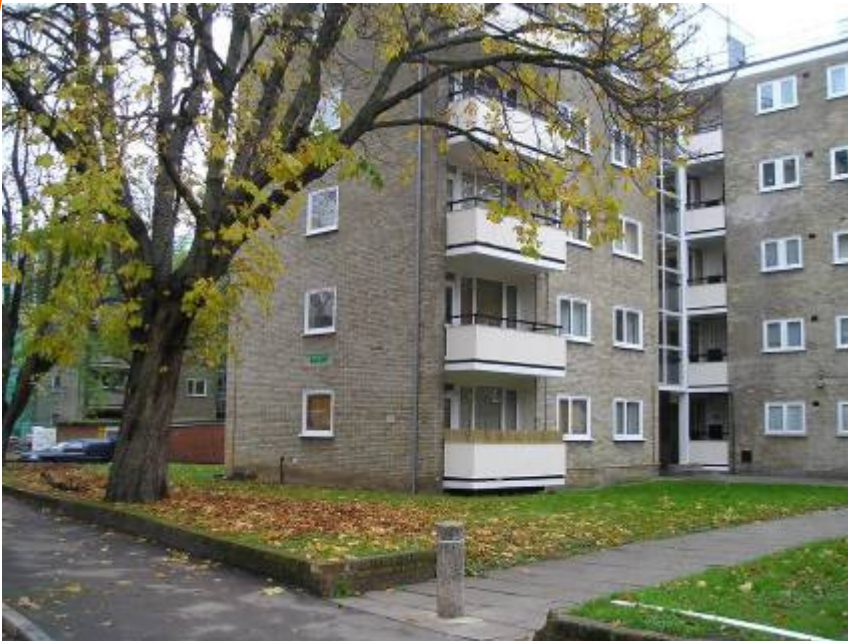
It is believed that the original subsidence was caused by the trees pictured below and anti heave precautions had to be taken into account. Contract specific temporary stools were designed to provide stability whilst the new reinforced raft foundation was installed.

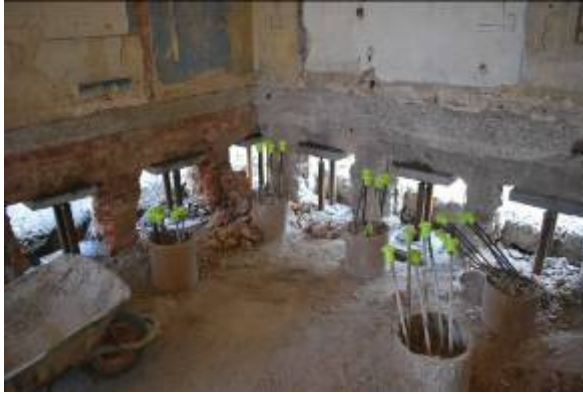
#### Mass Concrete Underpinning

In order to provide suitable bearing for the temporary support props to the external walls mass concrete underpinning sections were cast to support the existing concrete downstand slab edge.

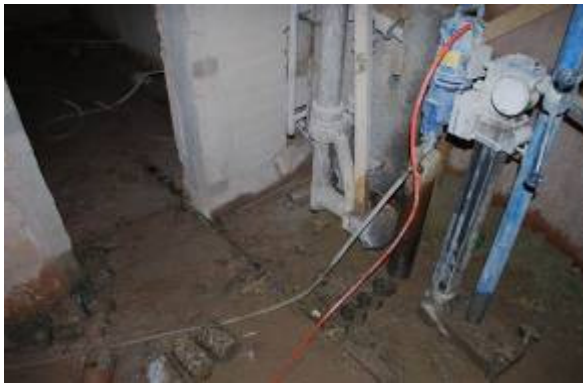
#### Diamond sawing of existing reinforced concrete slabs and reduced level excavation

The existing reinforced concrete floors had to be diamond cut (both sawing and chain drilling) and detached from the existing walls to reduce vibration and noise. The slab was then broken up and the reduced level excavation completed.

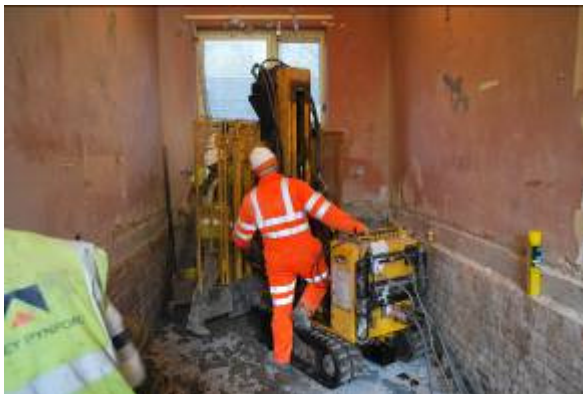
#### Installation of 300 mm diameter piles

The piles were installed using a specialist mini piling rig capable of drilling to 20+m the piles for this project were installed to 16 m tremmie grouted as necessary to deal with ground water.

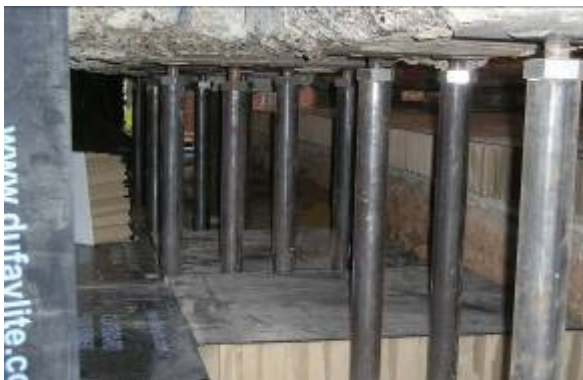
#### Installation of the Raft Slab

In order to ensure the stability of the building each raft slab was cast in 3 sections. The first part of the process was to install temporary support props to the walls (as shown). Then install anti heave precautions, tie and fix the steel reinforcement and concrete the slab. The final element was to remove the temporary props to maintain the antiheave precautions.
