Abbey Pynford

Case Study— Magdellan Court

Jack in the House.....

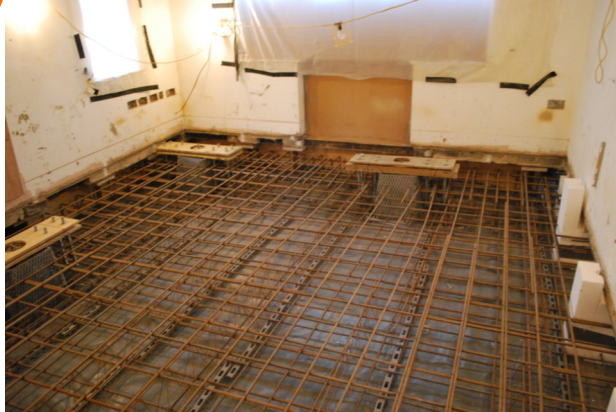
Raft slab reinforcement in place prior to concreting with temporary props in polystyrene boxing on the right hand side and templates supporting holding down bolts for jacking frames visible at pile positions.

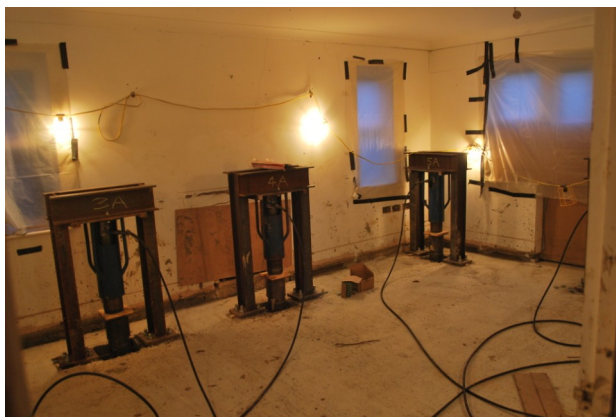
Jacking frames in place with Abbey Pynford AutoProps installed bearing on jacking tubes protruding from the piles but not connected to the slab.

Jacking was achieved by bolting lifting frames to fixings cast into the raft slab at each pile position and by installing Abbey Pynford AutoProps between the frames and jacking tubes protruding from the top of each pile. The jacking operation was carried out in several cycles with the amount of lift individually calculated at each pile position and pre-set into the jacking system so that each part of the building was lifted by the appropriate amount to return the slab to level. Obviously the higher end of the slab was lifted only a nominal amount and the lowest part of the slab was lifted eventually by approximately by 100mm. Following completion of the jacking work and agreement with the clients Engineer that the best possible result had been achieved the final connection between the jacking tubes and the raft slab was made by a proprietary grouting process. After the curing of the grout the jacking frames and jacks were removed and the jacking tubes cut off flush with the raft slab.

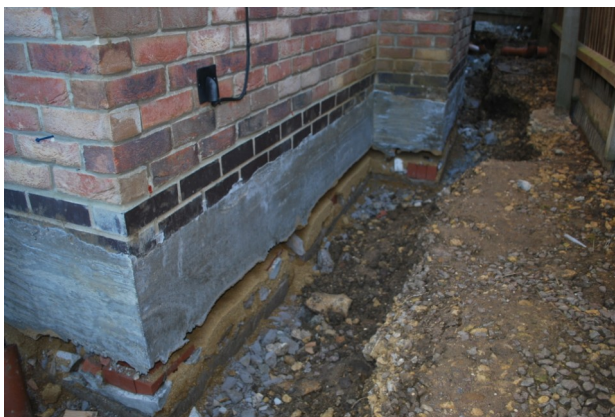
The building perimeter during the jacking operation is shown and the horizontal gap beneath the concrete slab edge resulting from the jacking operation is clearly visible. Following the jacking works the excavation around the perimeter of the building, necessary to entirely disconnect the structure from the ground was backfilled to cover the slab edge.
